Manhole Inspection Summary

Manhole # S23MM_044MH

Insp Date: **9/18/07 9:55 AM**

Location Address: **2509 DRUID HILL AVE**

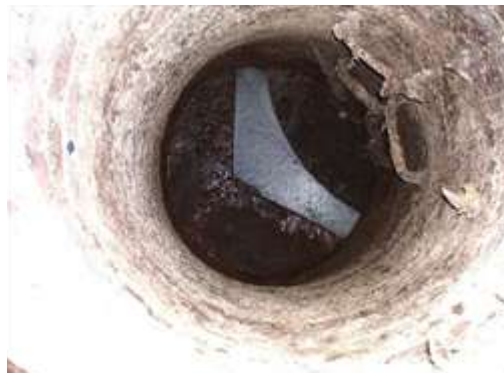
Top View

Corroded and missing steps. Evidence of surcharge - Bench debris.

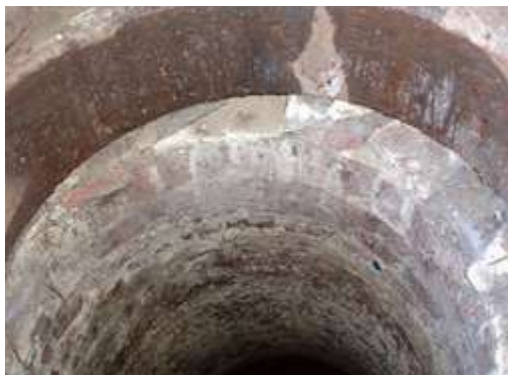
Defect

Frame leaks. Frame offset. Adjustment deterioration and infiltration. Barrel infiltration - other side.

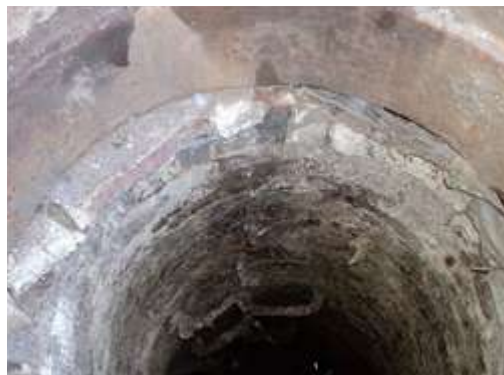
Defect

Frame leaks. Frame offset. Adjustment deterioration and infiltration. Barrel infiltration. Corroded and missing steps.

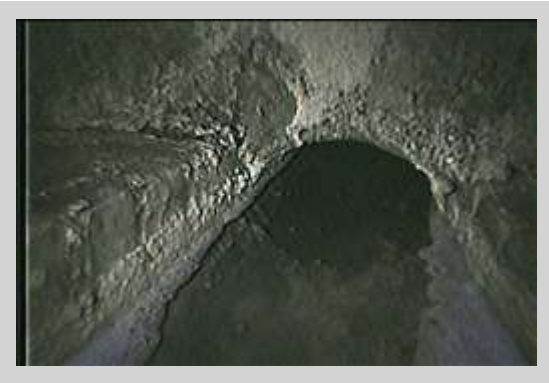
8 in. Circular Gravity Sewer Pipe Out @ 12 O'Clock

Deposits: ☐ None ☒ **Mud** ☐ Sludge ☒ **Debris** ☒ **Grease**

Silt Depth: **3** (in.) Deposits Extent: **Medium**

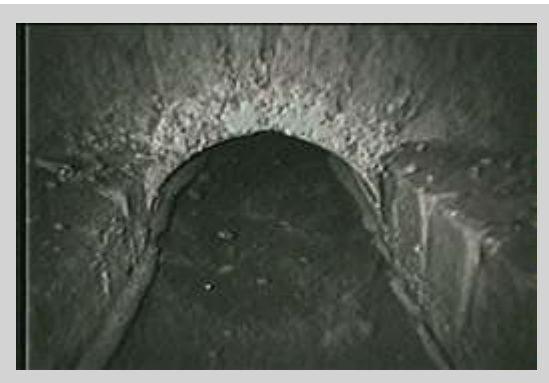
8 in. Circular Gravity Sewer Pipe In @ 4 O'Clock

Deposits: ☐ None ☒ **Mud** ☐ Sludge ☒ **Debris** ☒ **Grease**

Silt Depth: **3** (in.) Deposits Extent: **Medium**
